# SAFETY ALERT # 15

July 7th, 2006

### ***Glazing contractor critically injured when window assembly falls***

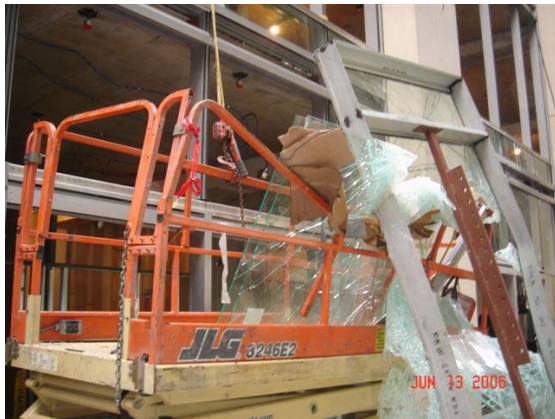
*A glazing contractor was adjusting a 4.5'x11' glass panel assembly on the 7th floor of a building. There were two workers (also glazers) in a scissor lift on the first floor directly below the glass assembly.*

*During the adjustment of the glass assembly, the assembly dislodged and fell down landing in the scissor lift critically injuring one of the workers in the scissor lift below.*

- When contractors are working at heights, the area below must be cordoned off to prevent people below from being struck by falling objects.
- Communication among contractors and workers is critical when we have people working from heights. In this case the communication process that was in place was not followed. We might need to be a part of the coordination process to prevent workers from being below other workers.

- The procedure for installation and adjustments for the glass assembly was not followed as it called for the “manipulator” to be hooked up to the glass assembly until the installation was complete.

- Typically, there should be a spotter on the ground to prevent people from being below the overhead work. In this case there was no spotter.
- A Job Hazard Analysis should have been completed. This process helps us to analyze the task, identify the hazard and determine the control or precautions necessary to perform the task safely.

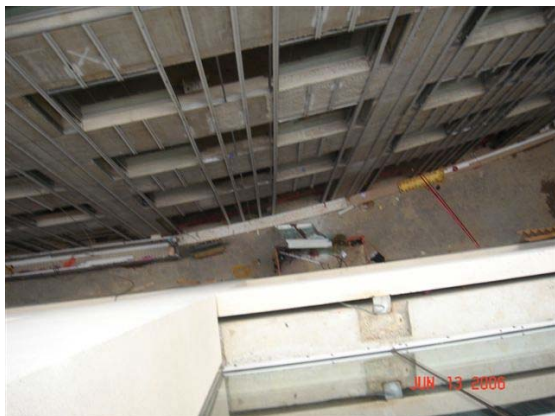
*Previously the contractor working above had communicated with the other contractors below. Because they were just "making adjustments" to the window assembly they felt that they did not need to communicate to the crew below. The assembly was installed using a manipulator (crane), however since the workers did not expect the unit to fall the manipulator was not used.*
